MONUMENT RECORD
State of Indiana - County of Monroe

Corner ID: Polk G-13

LAND CORNER RECORD

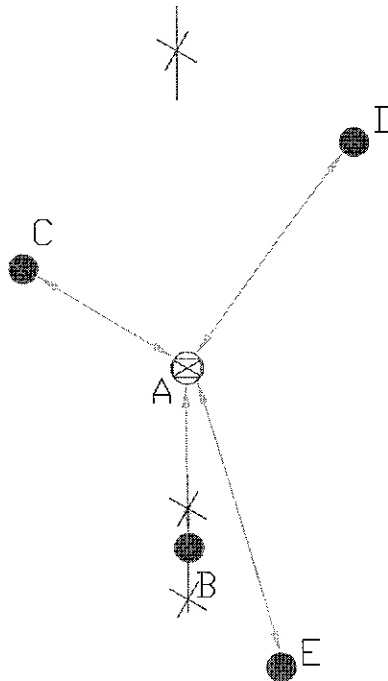
RECOVERY TIE DRAWING
Field Book 38 Page No. 72

A - 3" Monument
B - S 19° W 14.25' to Survey
Sign in 22" Red Oak
C - N 44° W 12.68' to Sign
in 4" Sugar Maple
D - N 62° E 39.40' to Sign
in 5" Sugar Maple
E - S 14° W 34.74' to Sign
in 12" Pignut Hickory
